IPMV51734

Problems and Cures

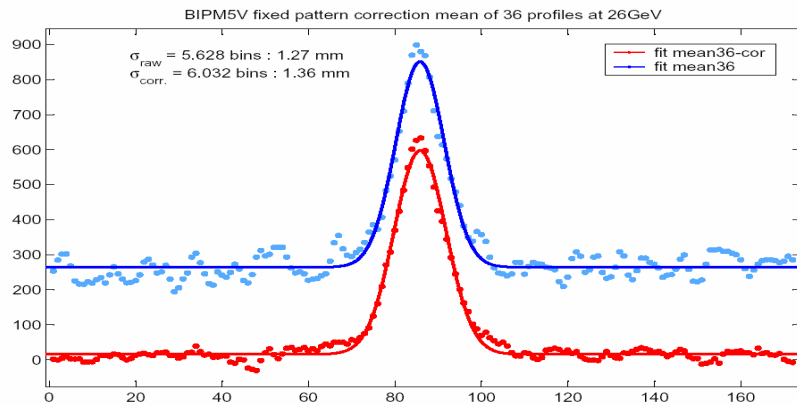
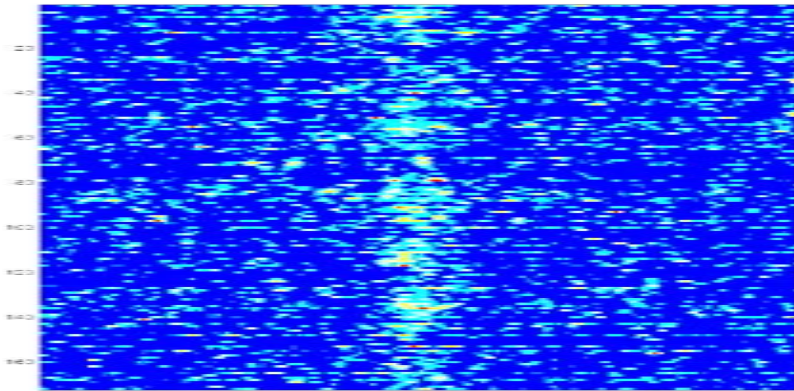
Pilot bunch @26 GeV

- Pilot bunch has been observed using intensified camera.
- Analysis of fixed pattern noise shows possibility of improving signal quality by subtraction, especially beneficial at low energy.
- At high energy, 50% too large sigma's were measured with bunch pilot (very small size): resolution limitation.

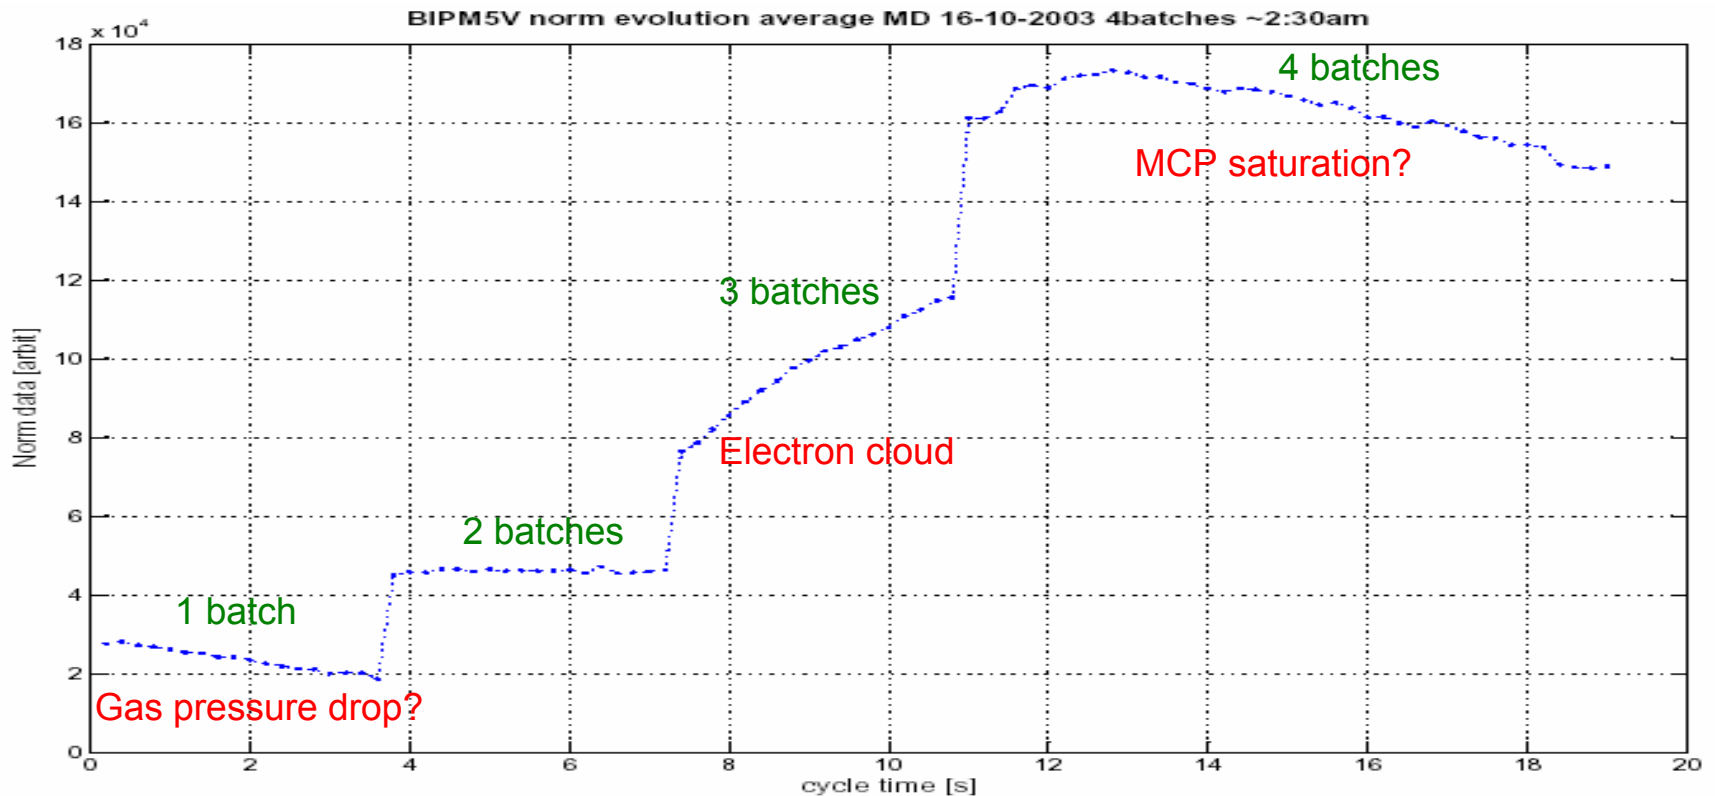
- Decreasing intensity until 2-nd injection:
 - Dropping vacuum pressure after vanishing e-cloud of previous cycle?
- Rising intensity after third injection:
 - Rising vacuum pressure due to electron cloud build-up?
 - Detected cloud electrons adding to useful signal?
- MCP saturation after acceleration:
 - Higher peak values due to beam size shrinking.
