IPMV51734

Problems and Cures

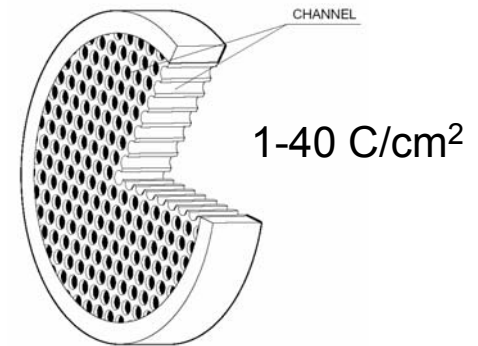
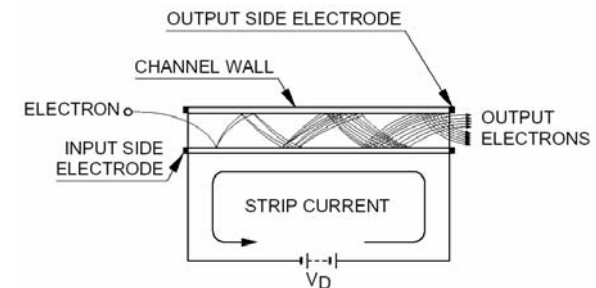
- Bad electrical contacts of phosphor screen after bake-out (200°C) of NEG:
 - Insertion of thin CuBe frame with flexible contacts for phosphor.
- Damage to central region of MCP due to high output signal:
 - Decrease of MCP gain compensated by image intensifier. Decrease MCP output current, increase of life time.
- Lighting up of phosphor screen with short LHC bunches at high energy (Even without HV applied!):
 - Removal of HV series resistances.
- Limited image resolution:
 - Closed diaphragm of camera lens by 50%.
- Tilt on video image due to stray B-field:
 - Addition of μ -metal screen, decreasing influence B-field on image intensifier.
 - Reduction of magnet current by 50%.

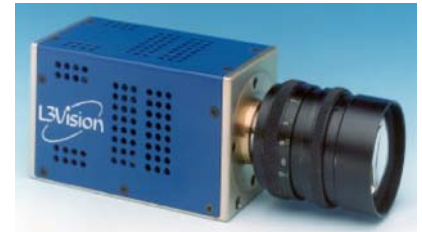
- Low Light Level camera:

- Lower noise.
- Higher resolution.
- Insensitive to B-field.
- Life-time insensitive to over exposure.

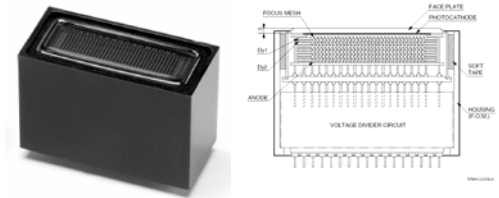
- 32 channel miniature photo multiplier tube:

- High speed turn/turn measurement for injection studies.

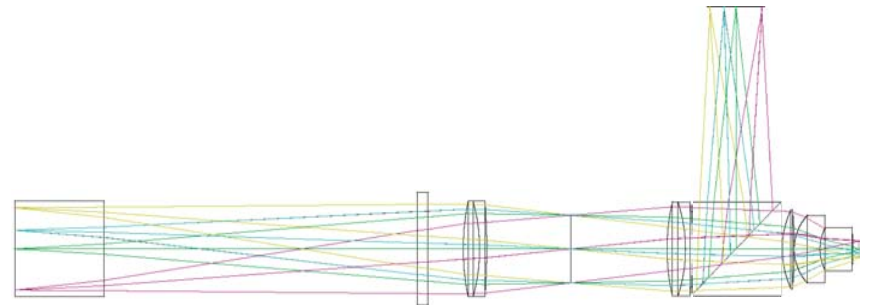
- Dedicated optics:

- Splitter.
- Higher aperture.
